**Flood Control Project Maintenance  
Levee Inspections**  
**LMA District Cover Sheet**  
**Spring 2020 Levee Inspection Results**

**Levee District No. 0001 (Glenn County)**

**Spring 2020 Levee Inspection Results**

Waterway			Bank	Unit Miles
Unit No. 01 Sacramento River			Right	12.23
	Spring (March - May)	Summer (June - August)	(September - November) Fall	Winter (December - February)
Unit Maintenance Rating (Fall Only)				
Date of Inspection	4/2/2020 - 4/2/2020			
DWR Inspector	Makar Sokol			
Accompanied By

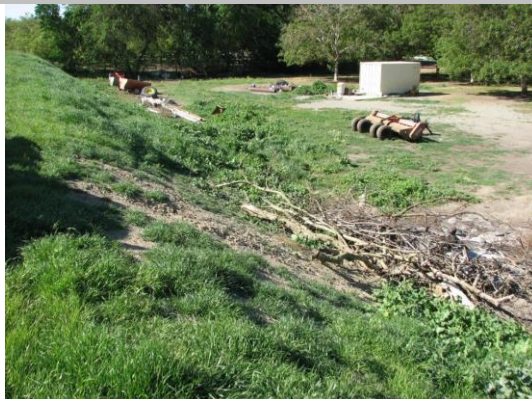
Photo 1 of 1 : SP\_2020\_LD0001G\_432\_73\_20200226\_00022.jpg

LM Start	0.02	Rating **	M	Issue No.	73
LM End	0.04	Issue Type +	En	Location *	LS
Category	Earthen Levee			GPS Latitude/Longitude	
				Start	End
Item	Encroachments			39.477372 °	39.477833 °
				-122.017602 °	-122.017484 °
DWR ID	DWR_LD0001G_01_s_2016_73				
Comment Code					
EQ : Equipment					
Inspector Comment					
Remove agricultural equipment from the landside toe.

View of the prunings pile and ag equipment at the landside toe.

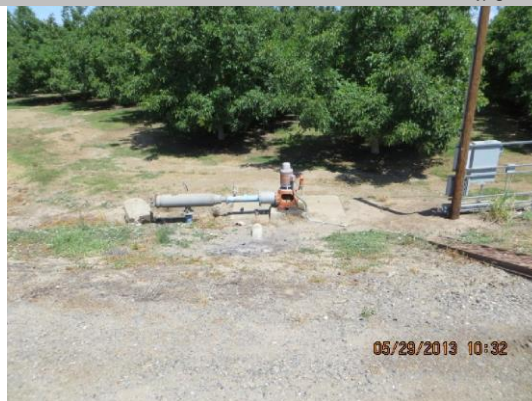
Photo 1 of 3 : UCIP\_SP\_2020\_14332\_23582.jpg

Pump at location of pipe on LS toe.

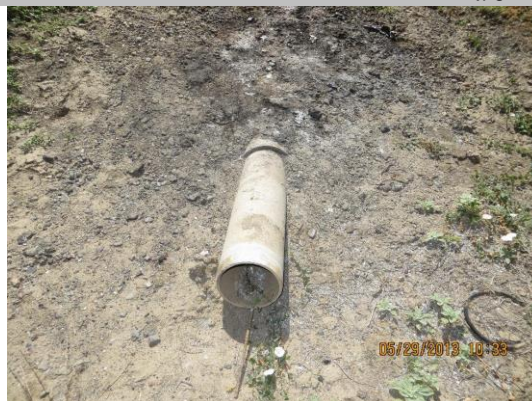
Photo 3 of 3 : UCIP\_SP\_2020\_14332\_23580.jpg

8-inch pipe sleeved through a 12-inch concrete pipe.

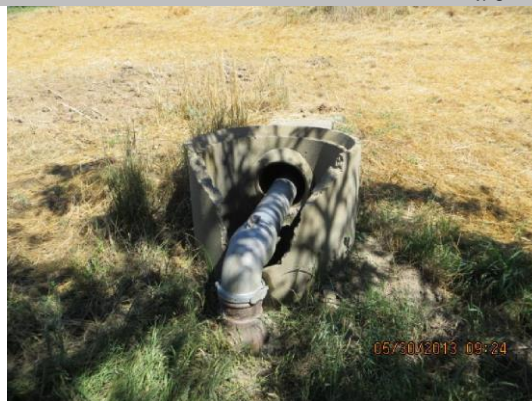
Photo 3 of 3 : UCIP\_SP\_2020\_51284\_23592.jpg

8-inch pipe sleeved through 16-inch pipe at LS toe.

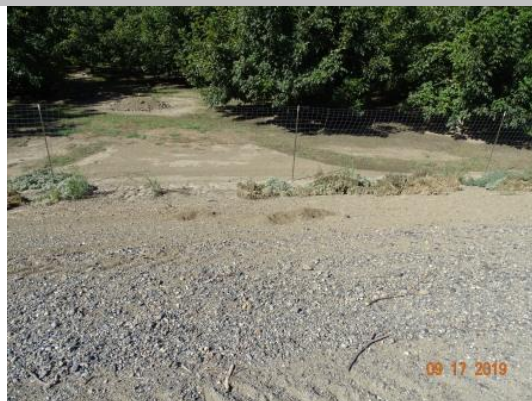
Photo 1 of 1 : SP\_2020\_LD0001G\_432\_84\_20200226\_00027.jpg

LM Start	5.78	Rating **	M	Issue No.	84
LM End	5.81	Issue Type +	Ma	Location *	LS
Category	Earthen Levee			GPS Latitude/Longitude	
				Start	End
Item	Animal Control			39.544295 °	39.544590 °
				-122.000934 °	-122.001047 °
DWR ID	DWR_LD0001G_01_f_2019_84				
Comment Code					
A3 : No rodents visible, but rodent burrows visible; need to backfill and compact or grout burrows.					
Inspector Comment

View of the rodent activity on the landside slope. Fall 2019.

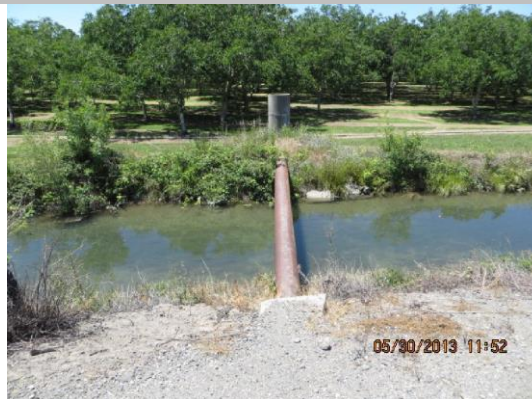
Photo 1 of 3 : UCIP\_SP\_2020\_14384\_23664.jpg

Pipe on LS toe with concrete standpipe visible.

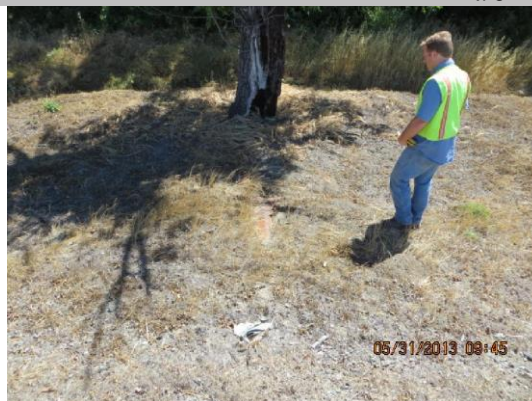
Photo 3 of 3 : UCIP\_SP\_2020\_53341\_23666.jpg

Pipe on WS slope.

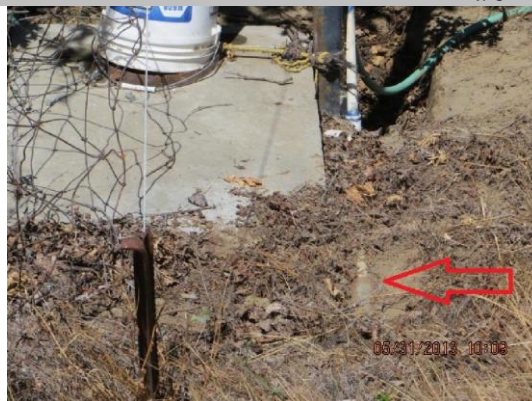
Photo 2 of 3 : UCIP\_SP\_2020\_16204\_27329.jpg

Pipe visible next to well with bucket over standpipe.

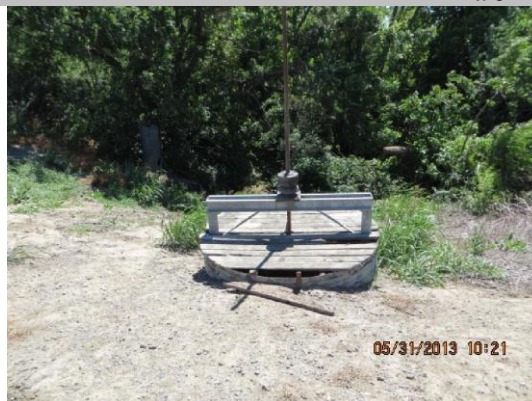
Photo 2 of 3 : UCIP\_SP\_2020\_14389\_23685.jpg

Slide gate in 8-foot diameter CMP riser on WS slope.

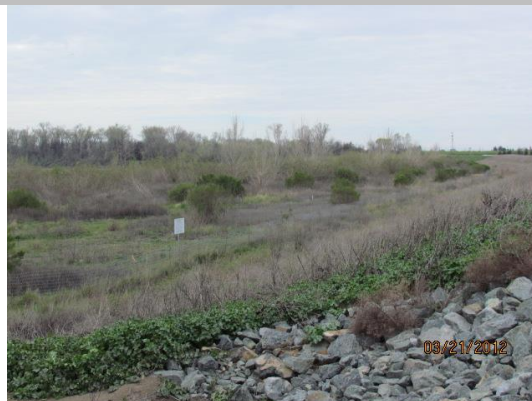
Photo 1 of 1 : SP\_2020\_LD0001G\_432\_8\_20200226\_00002.jpg

LM Start	9.50	Rating **	A/W	Issue No.	8
LM End	9.91	Issue Type +	Ob	Location *	WS
Category	Earthen Levee			GPS Latitude/Longitude	
				Start	End
Item	Vegetation			39.596192 °	39.601489 °
				-122.002573 °	-121.999529 °
DWR ID	DWR_LD0001G_01_s_2012_8				
Comment Code					
V8 : Environmental Requirements.					
Inspector Comment

View of the Army Corps of Engineers mitigation site.

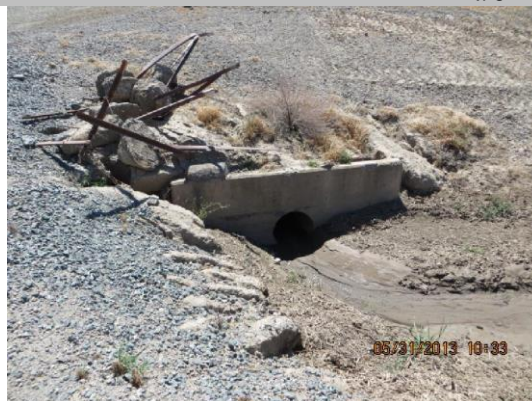
Photo 2 of 3 : UCIP\_SP\_2020\_14390\_23689.jpg

Concrete headwall and pipe at LS toe.

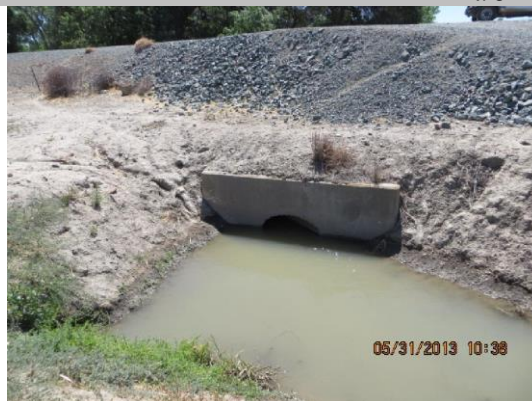
Photo 1 of 3 : UCIP\_SP\_2020\_14559\_23986.jpg

Pipe and headwall on LS toe.

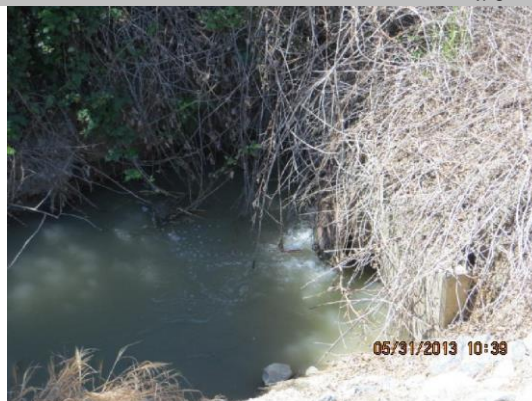
Photo 3 of 3 : UCIP\_SP\_2020\_14559\_23984.jpg

Pipe, flapgate, and headwall on WS toe.

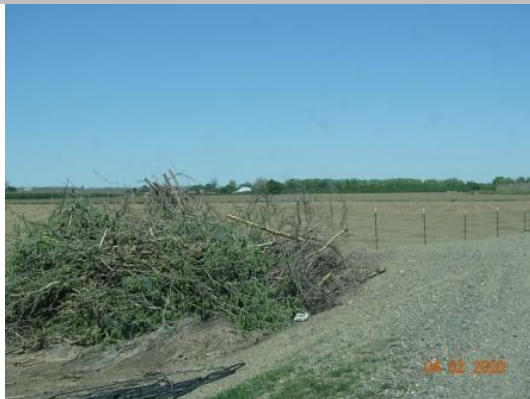
Photo 1 of 1 : SP\_2020\_LD0001G\_432\_76\_20200413\_00105.jpg

LM Start	10.83	Rating **	M	Issue No.	76
LM End	10.83	Issue Type +	En	Location *	LS
Category	Earthen Levee			GPS Latitude/Longitude	
				Start	End
Item	Encroachments			39.613387 °	39.613387 °
				-121.994375 °	-121.994375 °
DWR ID	DWR_LD0001G_01_s_2020_76				
Comment Code					
PR : Prunings					
Inspector Comment

View of the prunings at the landside toe. Spring 2020.

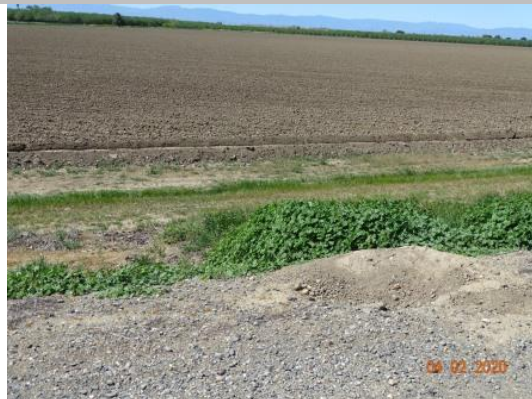
Photo 1 of 1 : SP\_2020\_LD0001G\_432\_66\_20200413\_00106.jpg

LM Start	11.10	Rating **	M	Issue No.	66
LM End	11.18	Issue Type +	Ma	Location *	WS
Category	Earthen Levee			GPS Latitude/Longitude	
				Start	End
Item	Animal Control			39.617252 °	39.618192 °
				-121.994605 °	-121.995609 °
DWR ID	DWR_LD0001G_01_f_2015_66				
Comment Code					
A3 : No rodents visible, but rodent burrows visible; need to backfill and compact or grout burrows.					
Inspector Comment

View of the rodent holes along the waterside slope. Spring 2020.

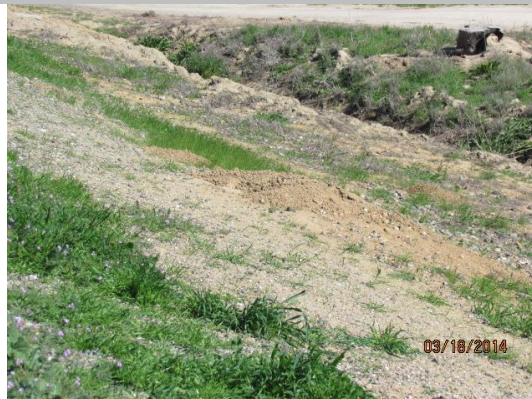
Photo 1 of 1 : SP\_2020\_LD0001G\_432\_48\_20200226\_00011.jpg

LM Start	11.51	Rating **	M	Issue No.	48
LM End	11.57	Issue Type +	Ma	Location *	WS
Category	Earthen Levee			GPS Latitude/Longitude	
				Start	End
Item	Animal Control			39.622083 °	39.622821 °
				-121.998858 °	-121.999244 °
DWR ID	DWR_LD0001G_01_s_2014_48				
Comment Code					
A3 : No rodents visible, but rodent burrows visible; need to backfill and compact or grout burrows.					
Inspector Comment

View of the rodent activity along the waterside slope.

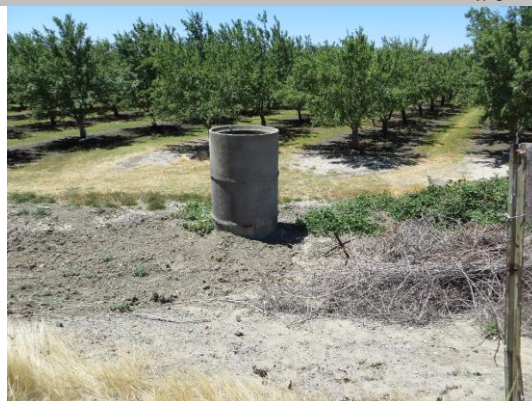
Photo 1 of 3 : UCIP\_SP\_2020\_14567\_24017.jpg

Concrete standpipe on LS toe.

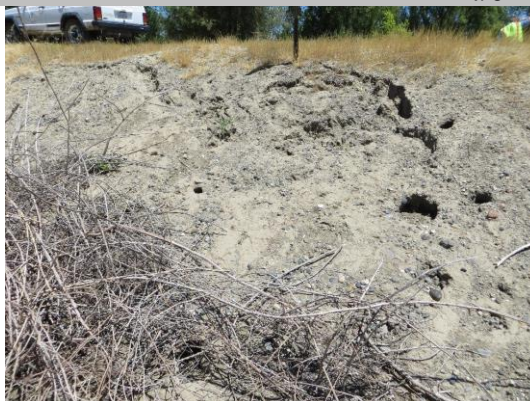
Photo 3 of 3 : UCIP\_SP\_2020\_14567\_24015.jpg

Erosion and sloughing on LS slope possibly due to rodent activity.

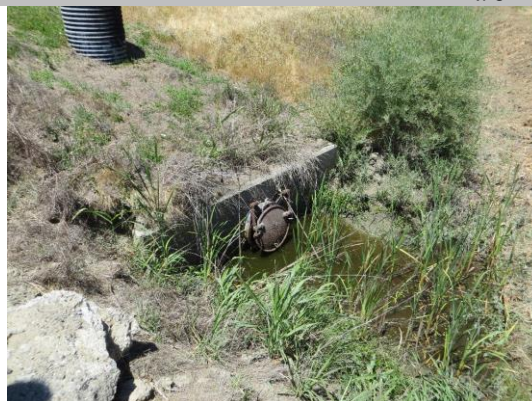
Photo 3 of 3 : UCIP\_SP\_2020\_14569\_24024.jpg

Headwall and flapgate on WS toe.
